## **Limited Visual Dam Safety Inspections**

**Nuuanu Dam No. 4**

**Oahu, Hawaii**

**May 2006**

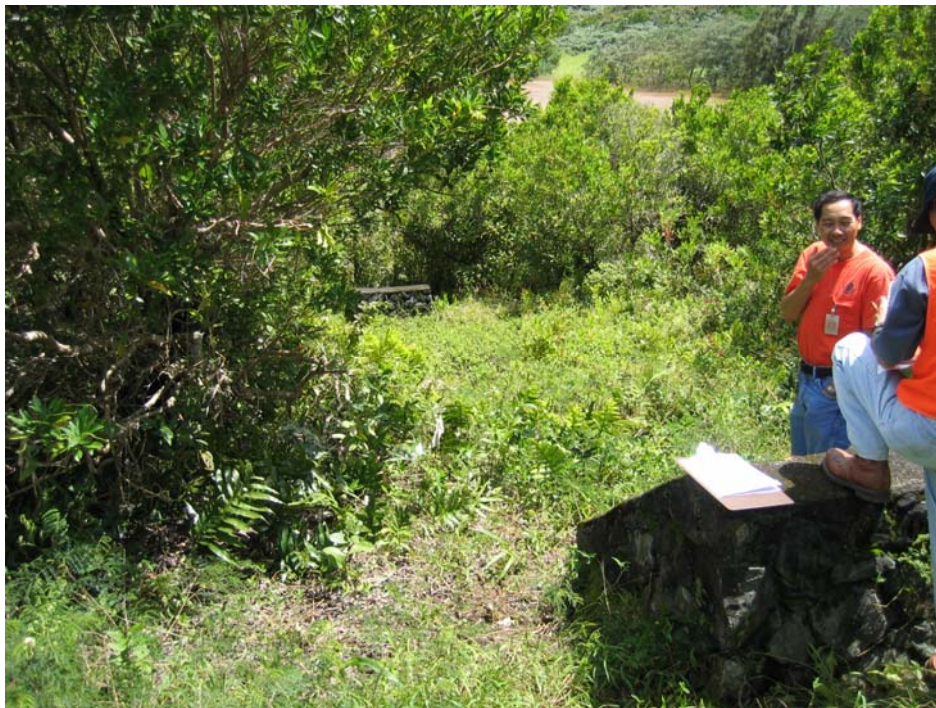
The upstream slope varied in slope and was roughly 1V to 4H (Vertical / Horizontal). A fitted rip rap rock slope protection was observed. Vegetation was observed growing between the rocks.

**Photo 1 Upstream slope and piezometers.**

- a. The upstream slope was not inspected.
- b. The upstream slope was not visible due to high grass and bush vegetation. Clear high vegetation and maintain low to enable easy visual inspection.
- c. Tree(s) were observed on the dam embankment. Trees have been identified as the probably cause of piping failures, and can possibly cause severe damage to the embankment if they are uprooted during a high winds. Corrective action is

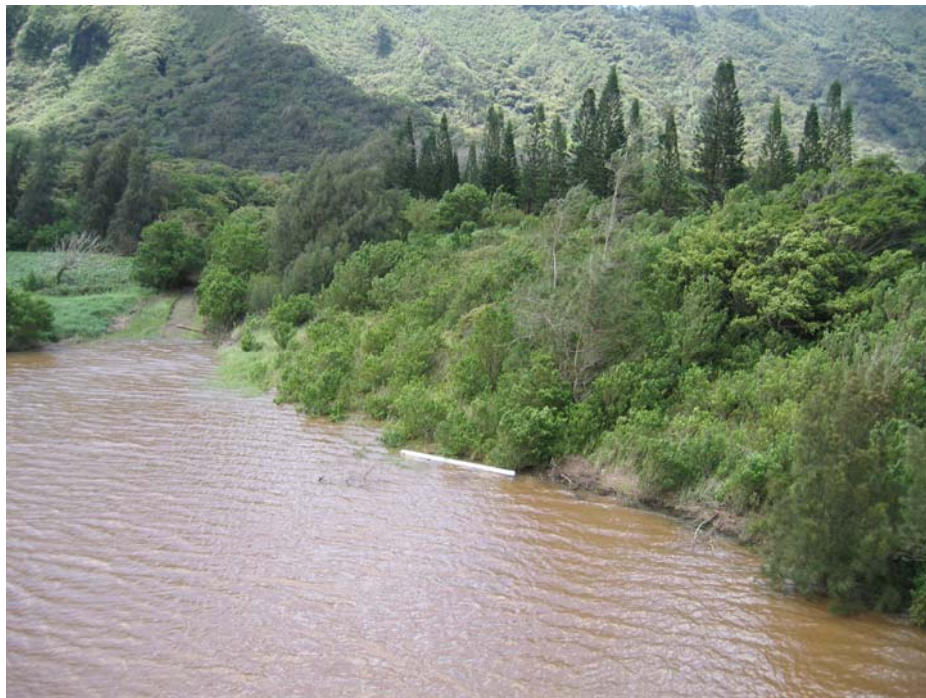
**Photo 2 Upstream slope and spillway entrance.**

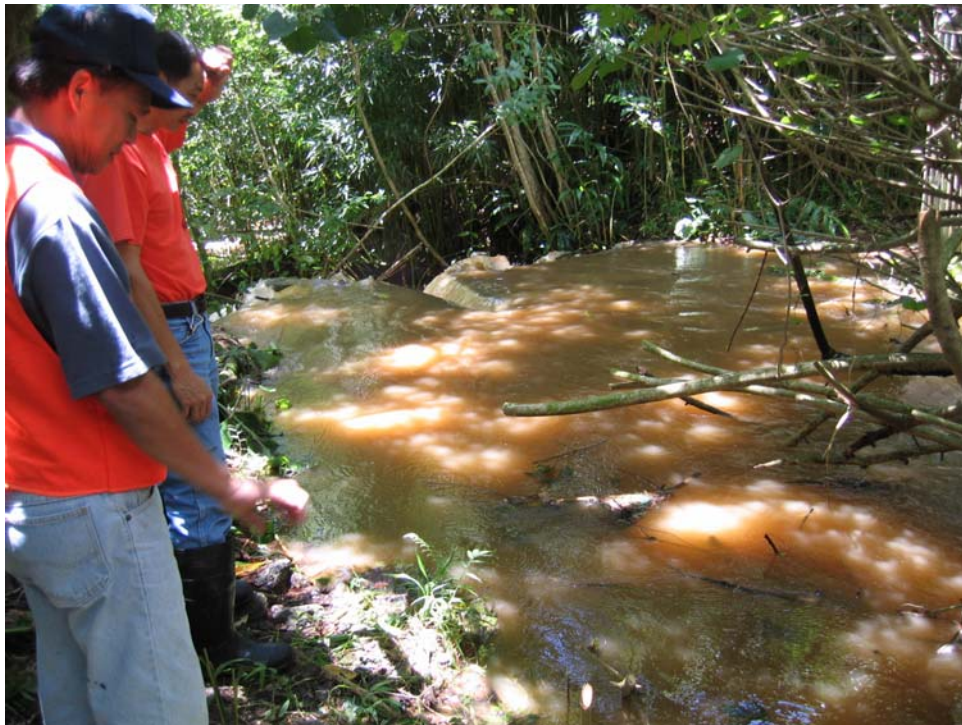
**Photo 3 Weir on outlet channel.**

- a. The outlet works were not tested.
- b. The outlet works appeared to be in fair to poor condition and requires corrective action.
- c. Were not visible due to high grass and bush vegetation. Clear high vegetation and maintain low to enable easy visual inspection.
- d. Consideration may be given to installing another gate at a lower elevation to maintain better control of the reservoir level.
- e. Monitor outlet channel weir more often during higher pools.

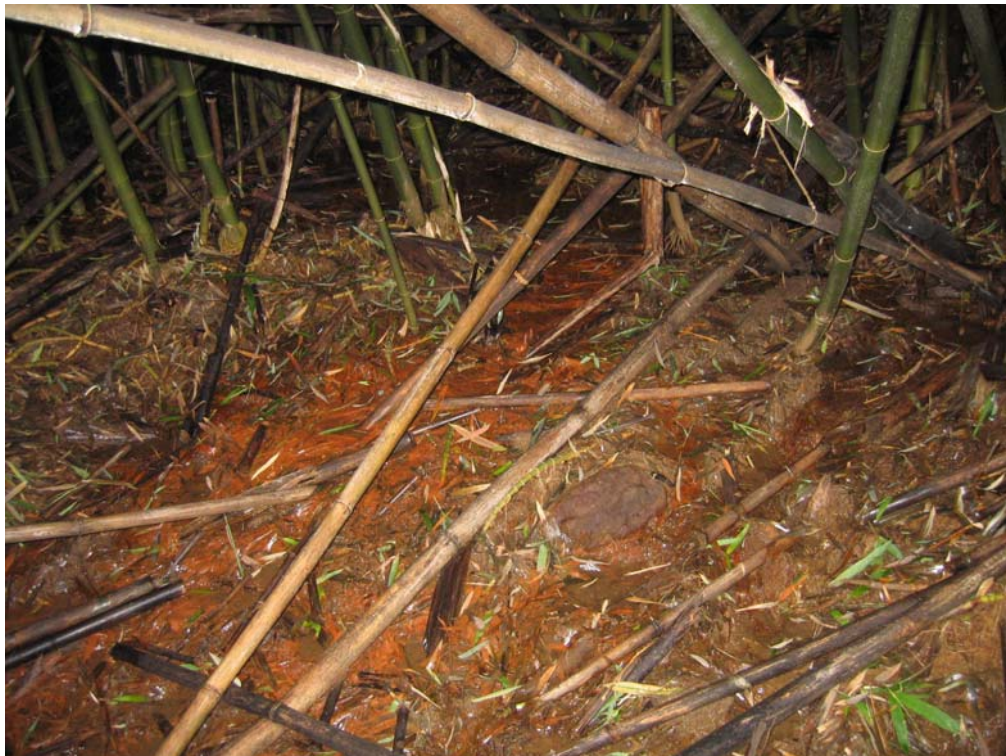
Areas were noted along the toe that could be possible seepage spots. These locations were observed near the base of the center stability berm, left side and also the left side closer to the outlet channel. The water that was seeping appeared to be moving relatively slow and seemed to be clear.

**Photo 4 Seepage area 3**

Seep Spot Number 2 + 3  
☐ Green Vegetation ☒ Wet or Muddy Ground ☒ Ponding Water ☐ Not Visible ☐ None Observed  
☒ Flowing, Description: New seepage detected at seepage area 2  
Water Clarity: ☒ Clear ☐ Some particles ☐ Muddy ☐ Other: \_\_\_\_\_  
Description: Iron stained

- e. Seepage/Ponding water was observed. Monitor and conduct further investigation to locate the source of water and extent of any possible hazardous or developing condition.

- f. It is recommended that a weir downstream of seep area on the left side be installed in a near by ditch to monitor seepage.

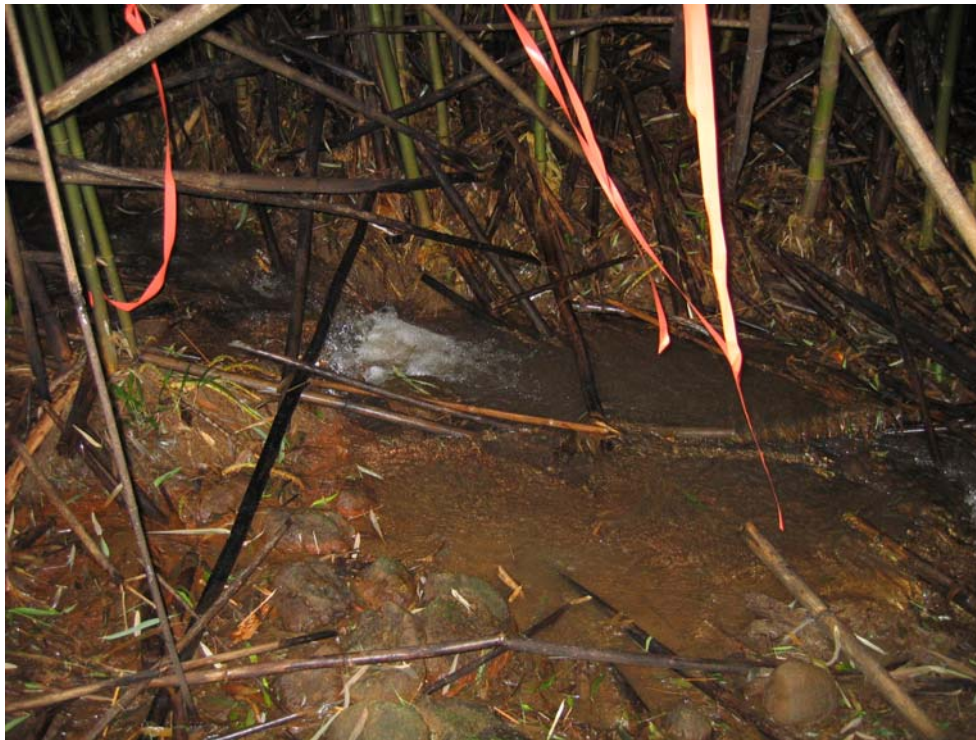
**Photo 5 Seepage area 2.**

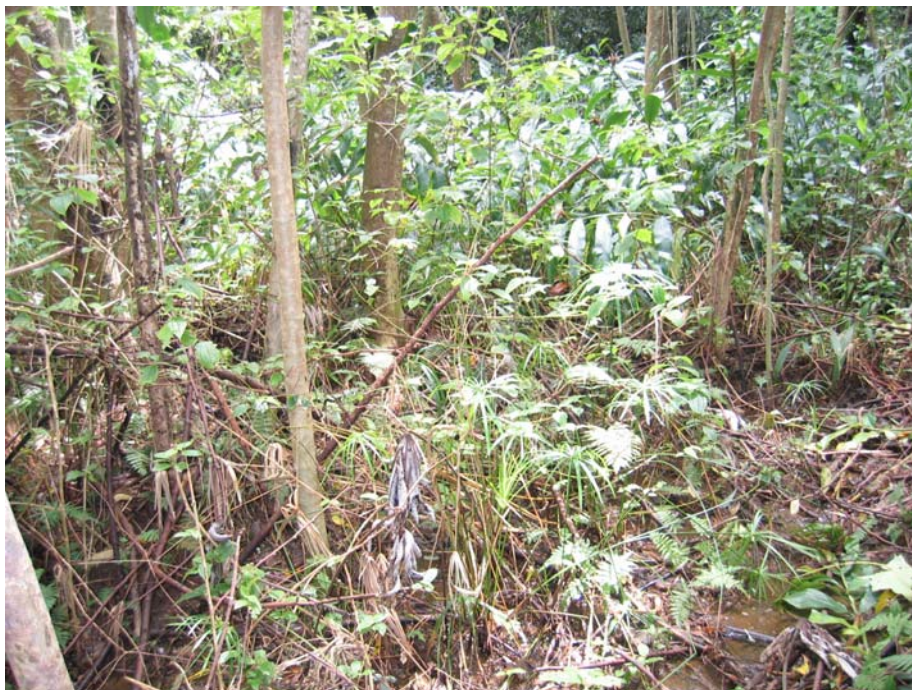
**Photo 6 New seepage in area 2.**

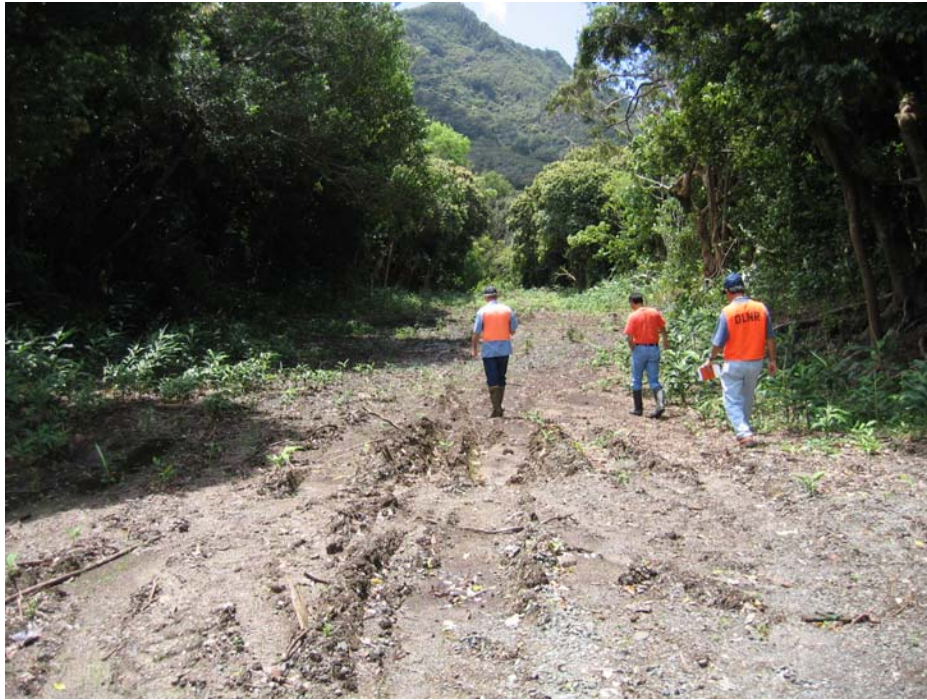
**Photo 7 Spillway looking downstream.**

- a. The Spillway appeared to be in fair to poor condition and requires corrective action.
- b. Trees are unacceptable in the spillway channel and approach. Take corrective action to address the woody vegetation problem and repair the damaged area.
- c. Unclear if spillway is adequately sized. Spillway should pass the probable maximum flood. Verify spillway capacity and take corrective action as required.

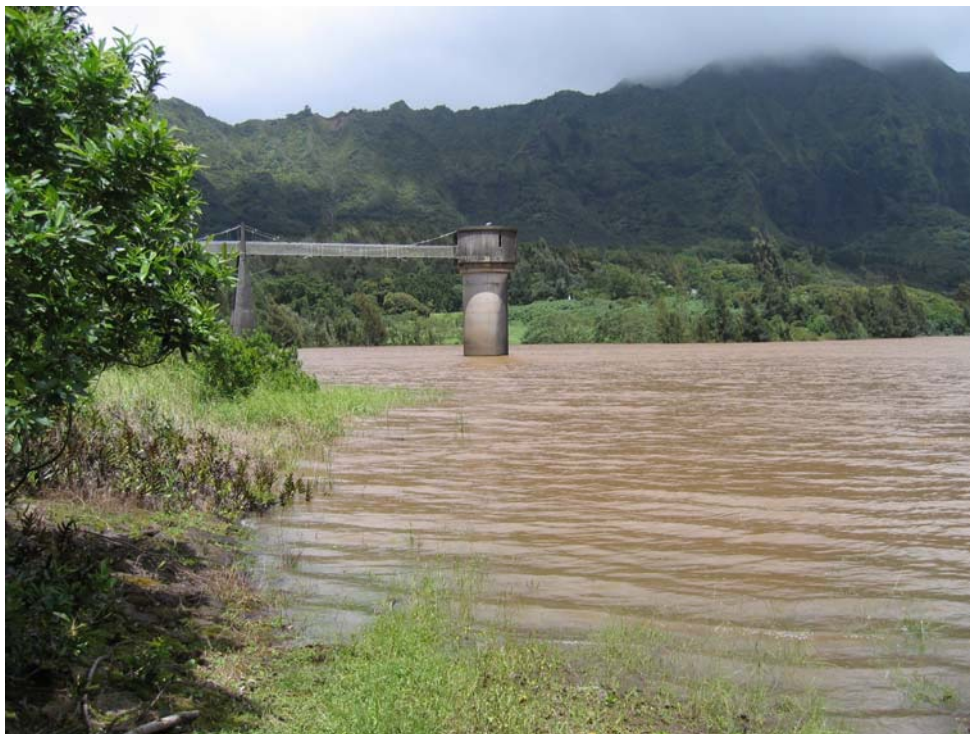
The reservoir level during the inspection was 40.7 ft per an electric measuring tape. A staff gage was not observed. However, an electric tape in the stilling well of the tower is used to monitor the reservoir level.

**Photo 8 Intake tower.**

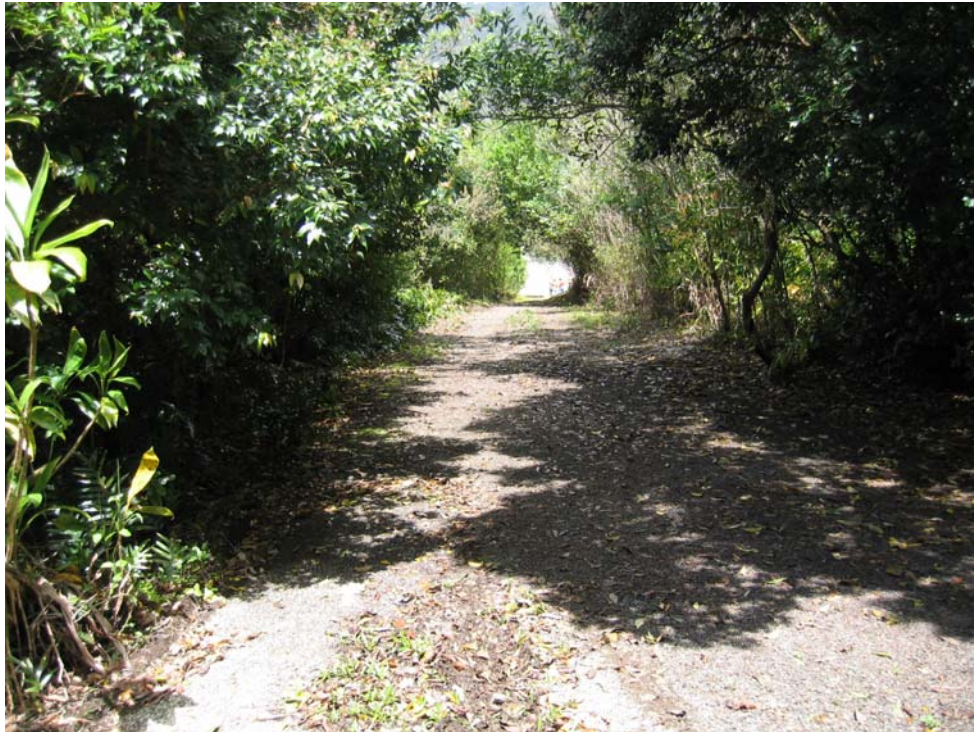
**Photo 9 Spillway entrance.**

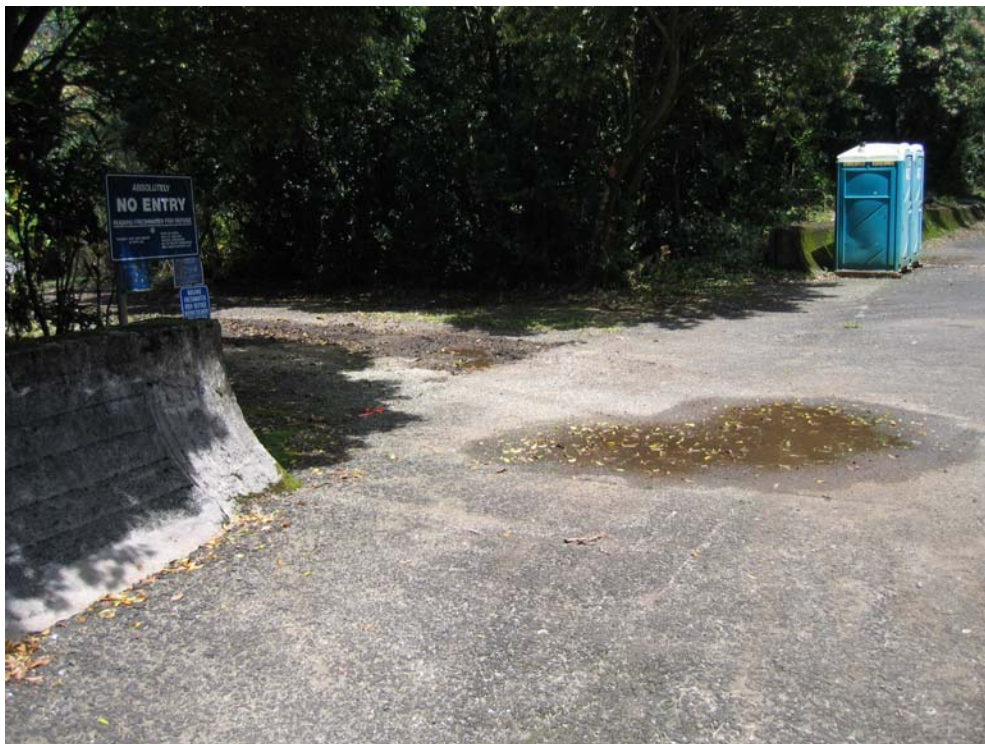
**Photo 10 Low area in spillway.**

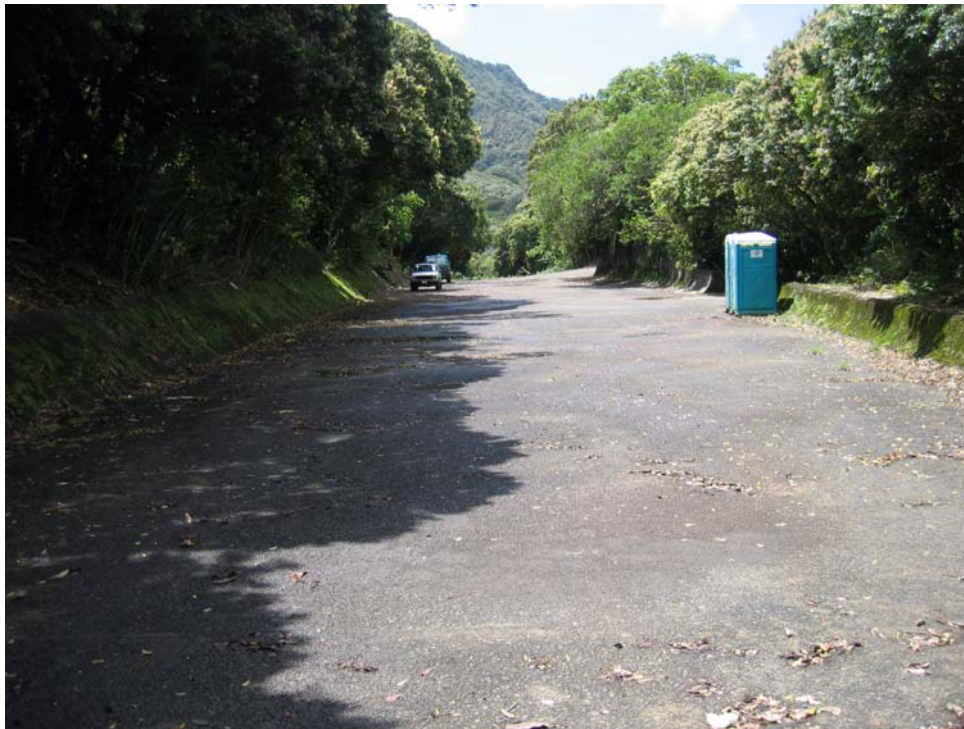
**Photo 11 Base of spillway looking downstream.**

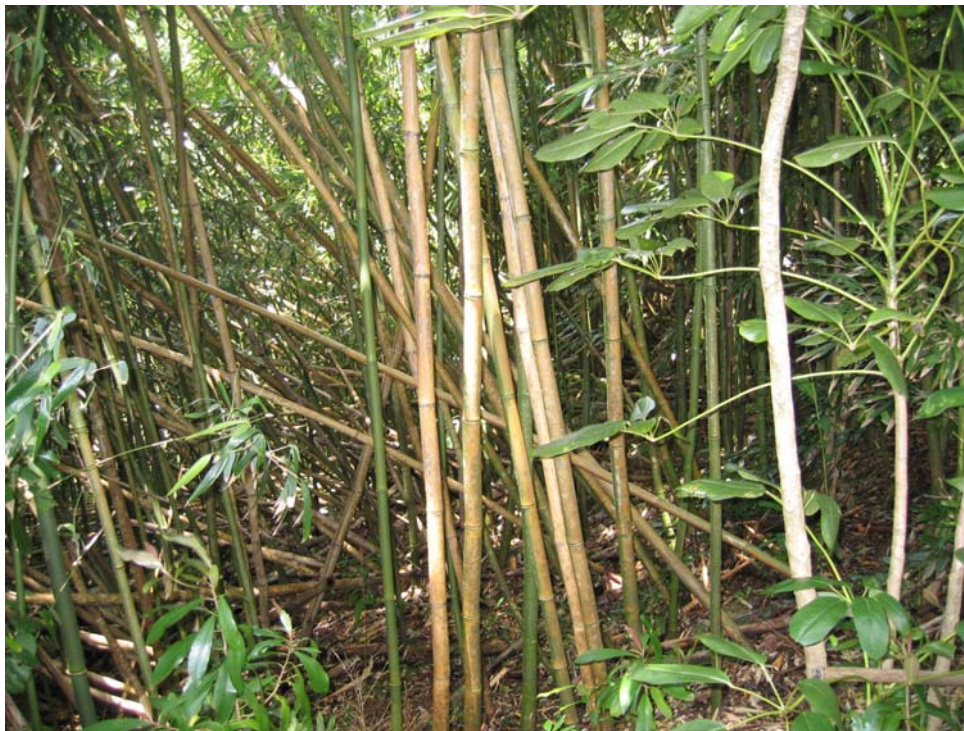
The downstream slope was in poor condition and not visible due to heavy vegetation.

Vegetation was observed on the downstream slope. The majority of the vegetation was woody trees ranging from 6: to the greater than 2 feet in diameter.

- a. The downstream slope appeared to be in fair to poor condition and requires corrective action.

**Photo 12 Downstream slope, dense vegetation.**

- c. Tree(s) were observed on the downstream slope. Trees have been identified as the probably cause of piping failures, and can possibly cause severe damage to the embankment if they are uprooted during a high winds. Corrective action is required to remove the tree hazards from the dam. Acceptable remedies include removal of the tree and its root structure down to a 2" diameter and reconstructing the damaged embankment section. All repair work shall be accomplished as per the requirements of licensed geotechnical or structural engineer. Routinely monitor the damaged area for signs of settlement and seepage.

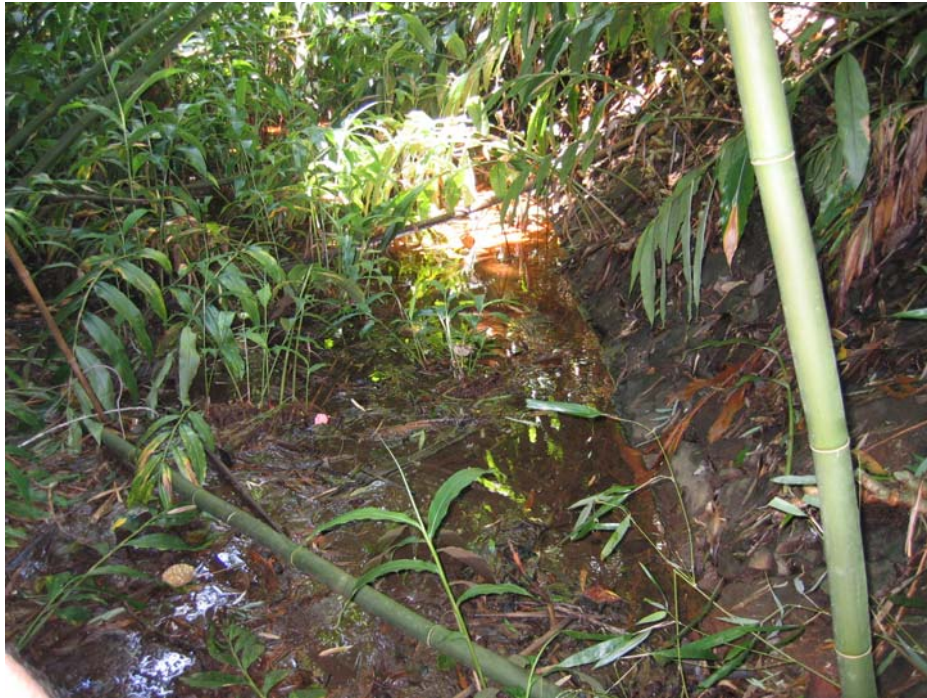
**Photo 13 Seep area 1.**

Seepage: Seep Spot Number 1  
☐ Green Vegetation ☐ Wet or Muddy Ground ☒ Ponding Water ☐ Not Visible ☐ None Observed  
☒ Flowing, Description: Small flow, trace  
Water Clarity: ☒ Clear ☐ Some particles ☐ Muddy ☒ Other: \_\_\_\_\_  
Description: Iron stained near seepage area, at base of toe berm left of DS Piezometers

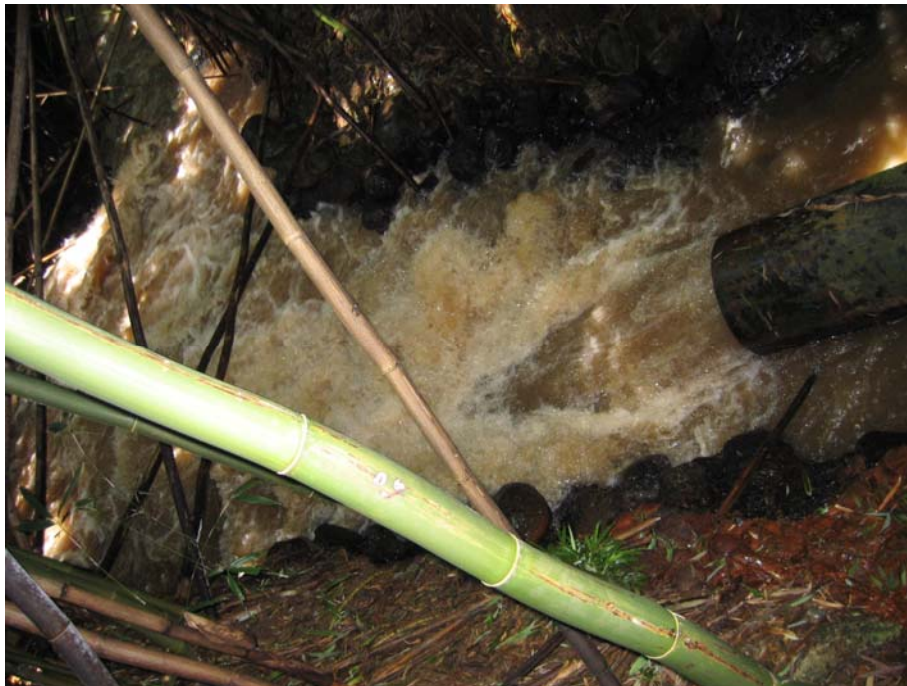
**Photo 14 Outlet pipe.**

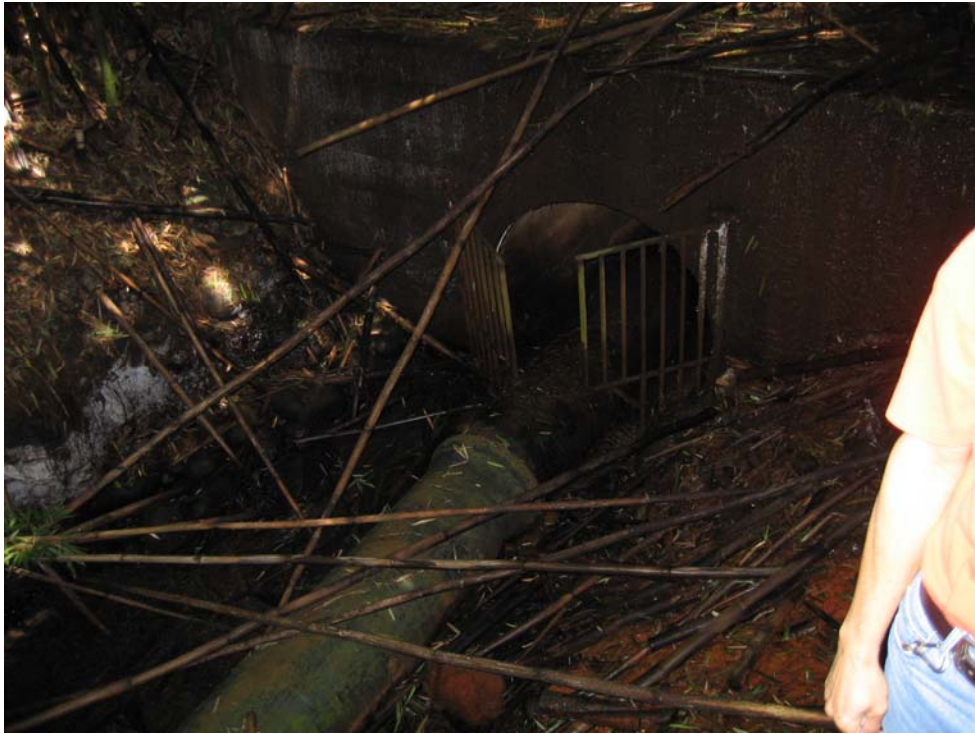
Seepage was not observed flowing near the exit of the outlet works from the dam.

**Photo 15 Outlet pipe exiting embankment.**
